PUGSLEY PARK / MONUMENT PARK PUBLIC WORKSHOP

Downtown Revitalization Initiative

City of Peekskill

November 15, 2022

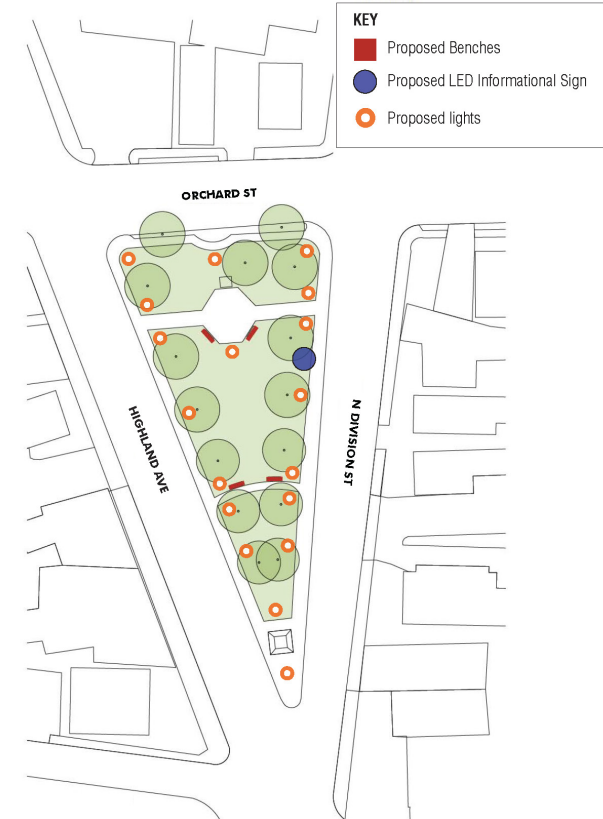
Proposed Site Plan

- Lighting – uplights for Civil War memorial statue;
- Decorative, pedestrian-scaled lighting throughout park;
- Lights on top of existing stone pillars
- Additional plantings; relocation of existing benches; and installation of new custom benches
- LED informational sign at existing bus stop

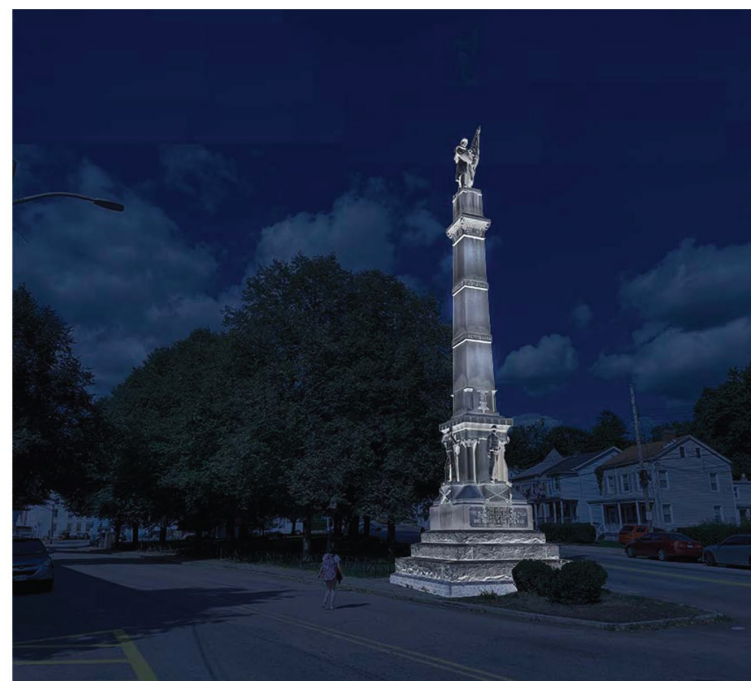
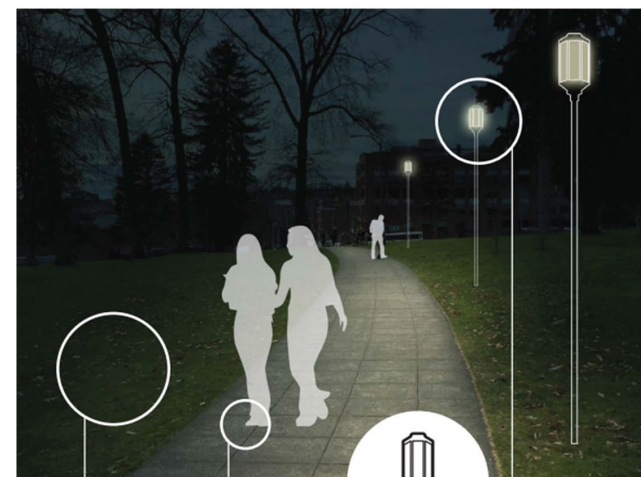
Large expanses of lawn should not be flooded with light.

Light prioritizes primary pathways and key intersections and destinations.

Pedestrian-oriented lighting strategies including appropriate mounting height and warmer color temperatures.
